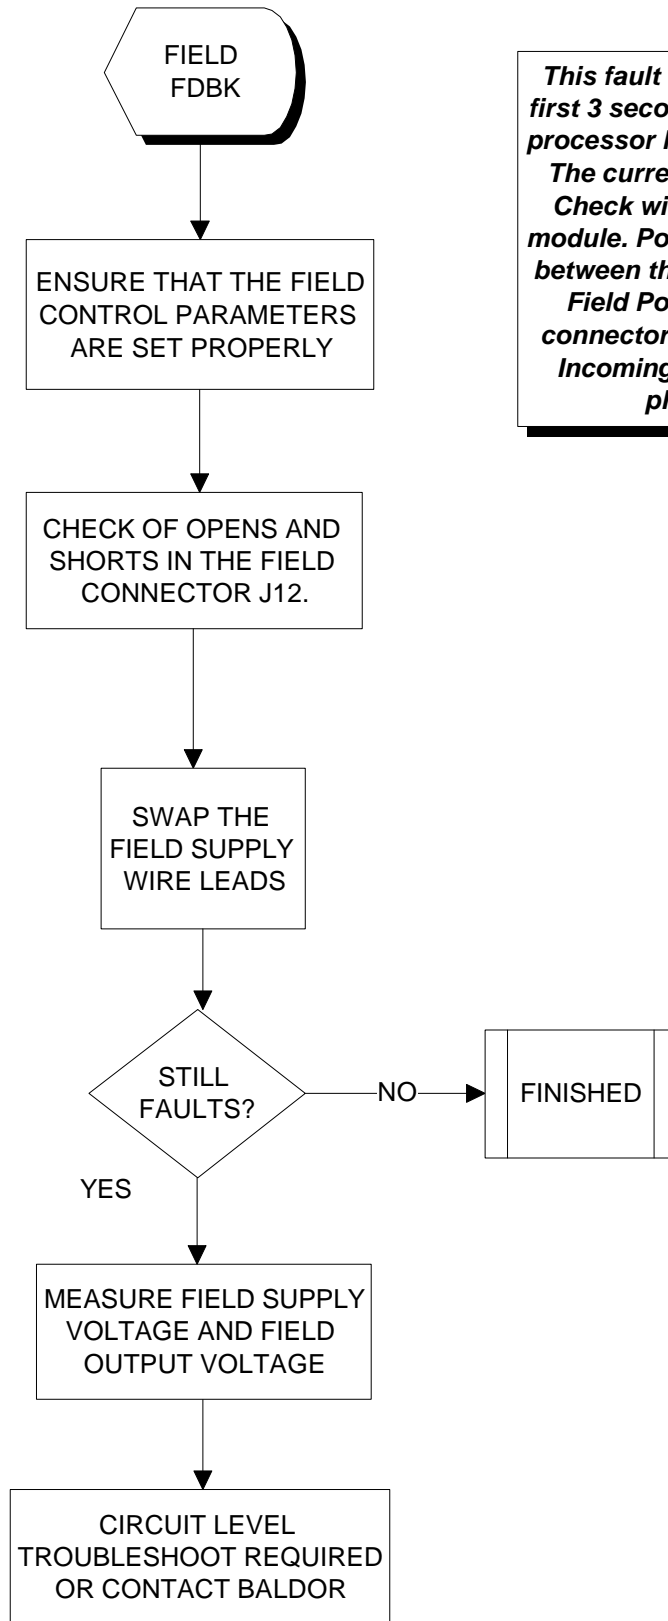
This fault can only happen in the first 3 seconds after power up. The processor looks at the field current. The current needs to be near 0. Check wiring to the field power module. Possible cause is an open between the J12 connector on the Field Power Module to the J3 connector on the Base ID board. Incoming line for field must be phased properly.

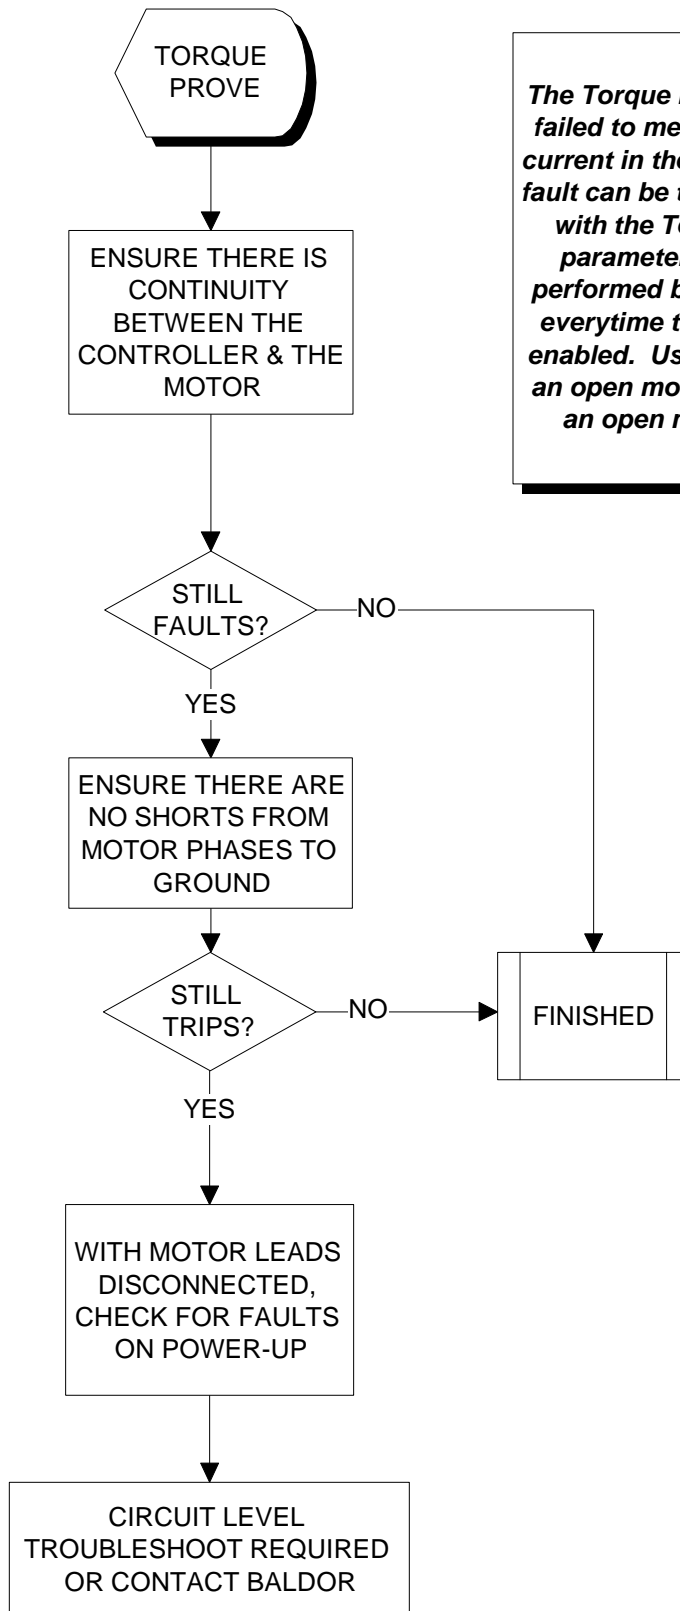
The Torque Proving test has failed to measure adequate current in the armature. This fault can be turned on and off with the Torque Proving parameter. This test is performed by the controller everytime the controller is enabled. Usually caused by an open motor contactor or an open motor winding
