CURRENT  
SENSE  
FAULT

LOST  
USER  
DATA

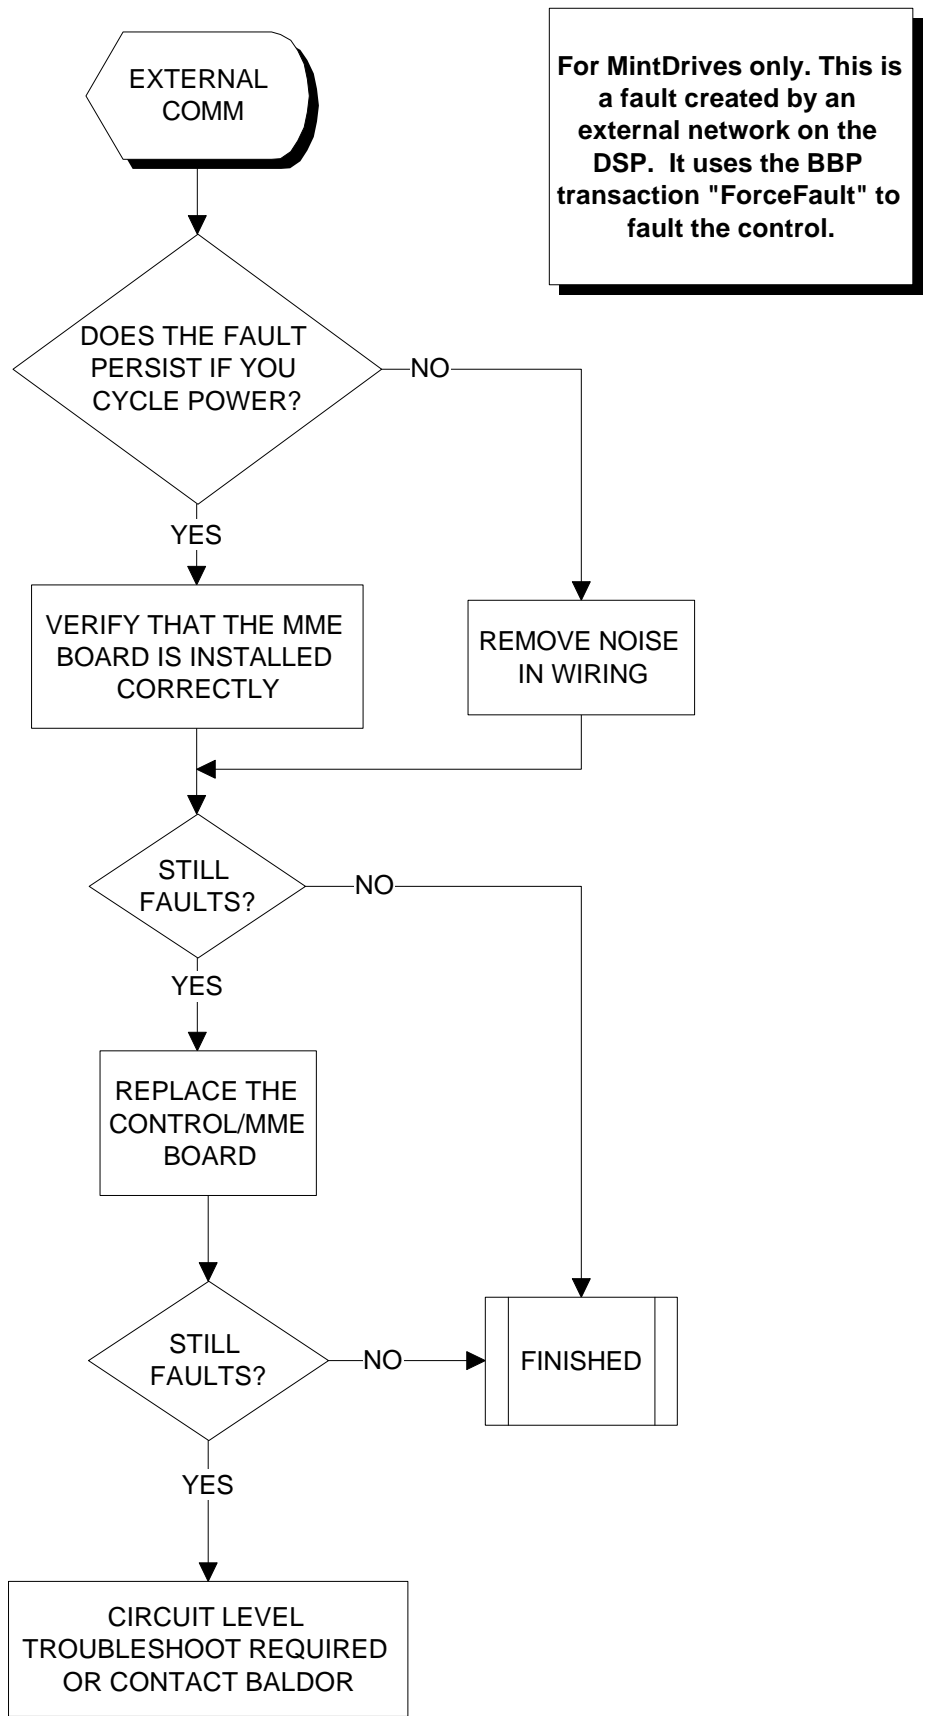
***This fault is only active when turned on in the External Trip Parameter, Level 2, Protection Block. An external over temperature or open circuit has occurred between J1-16 and J1-17.***  
***Use the Diagnostic Display DIGITAL I/O to verify the 9th position is a 1 (xxxxxxx1 xxxx).***

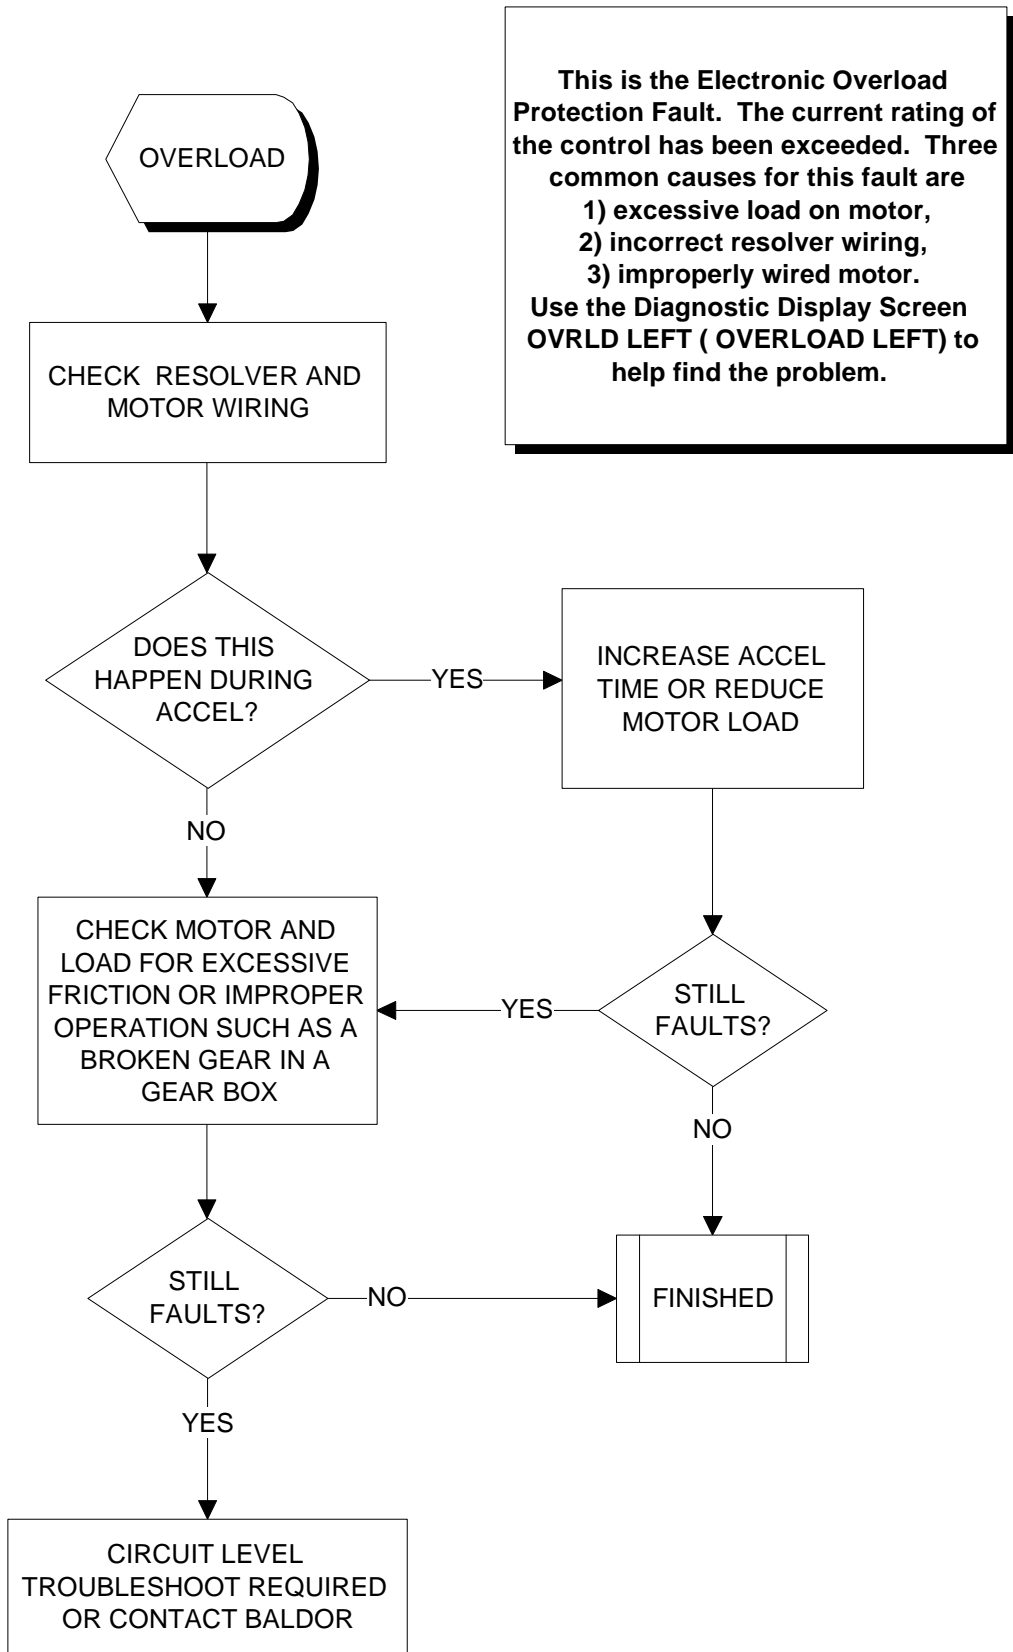
**The motor speed has exceeded 110% of the value in the Maximum Motor Speed parameter. The control board has detected that the encoder frequency has exceeded a software limit. Check for a loose coupling or electrical noise on the resolver signals. Also check the Speed Loop Parameters. Check for motor ground to the control.**

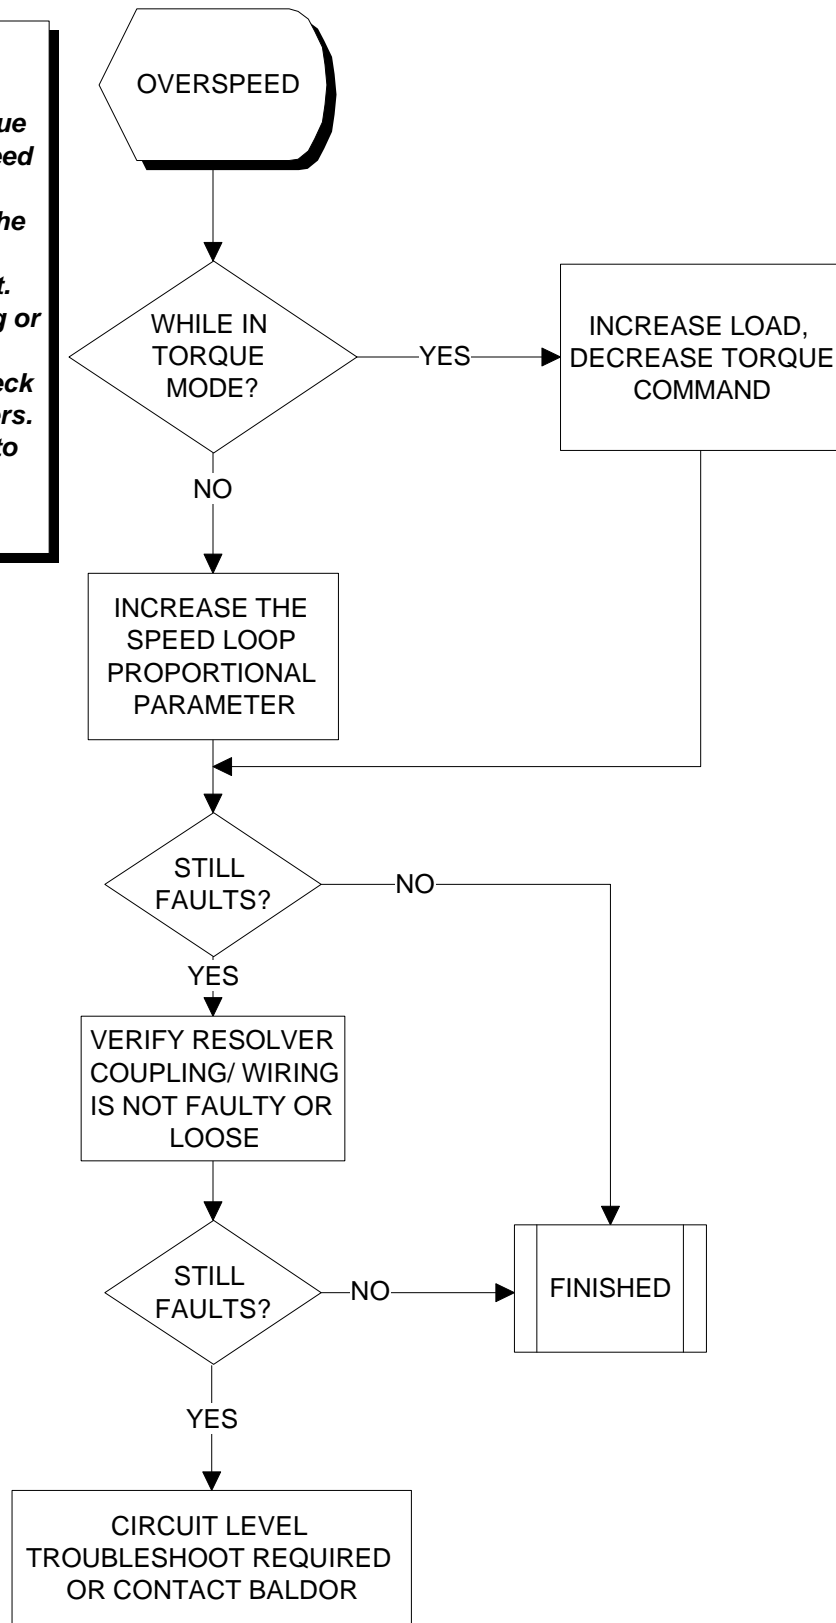
***There has been a desaturation of the IPM style power device or the Bus current threshold has been exceeded. This fault is detected by hardware on the gatedriver board when the LEM DC Bus current sensor has exceeded the hardware trip point. Verify the control was autotuned. Brushless parameters such as the Current Gains being too high or too low can cause this fault.***
